Inspection Report
Minerals Regulatory Program
Date: August 21, 2008

Mine Name: RLR Site #1	Permit Number: S0470093
Operator Name: Red Leaf Resources, inc.	Inspection Date: 08/19/2008
Inspector(s): Brett Gregory (for Leslie Heppler)	Time: 3:00 pm
Other Participants: None	Mine Status: Active

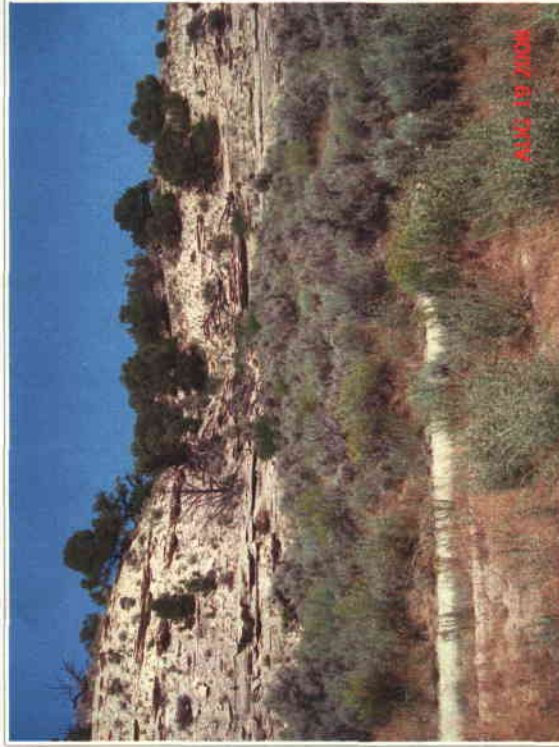
Location of the site submitted on the map.

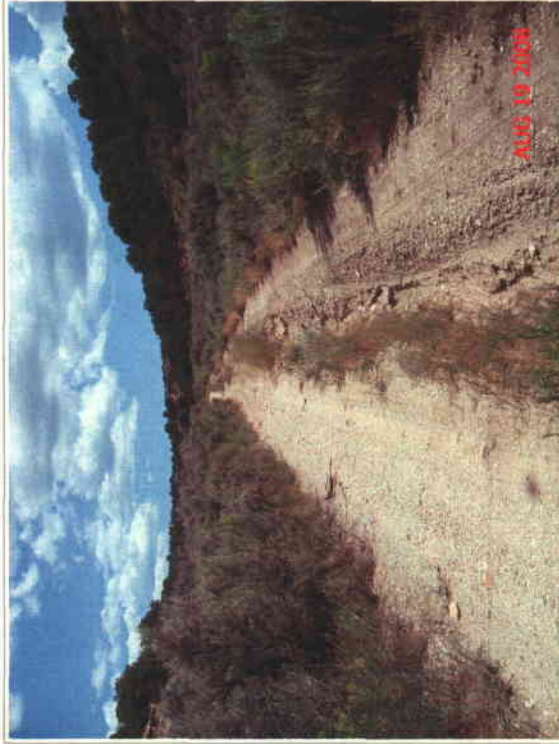
Inspection Summary: see attached photos
5. The road getting to the site is rough and ratty.

Deep rut in the road.

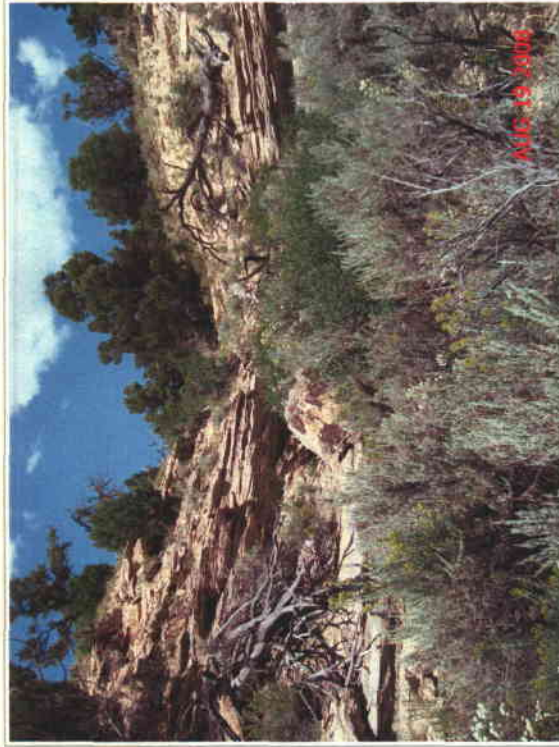
Existing sagebrush and plants.

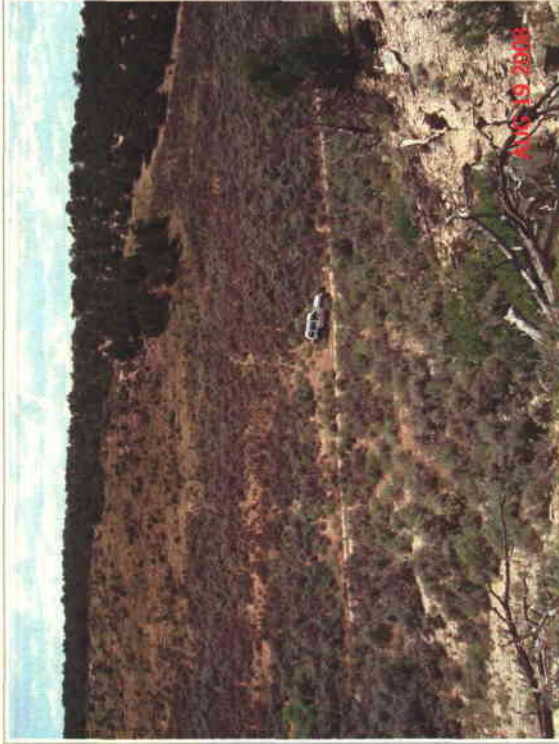
Looking down at the proposed road entrance.
